Manhole Inspection Summary

Manhole # S45GG_005MH

Insp Date: **8/14/08 11:45 AM**

Location Address: **WOLFE**

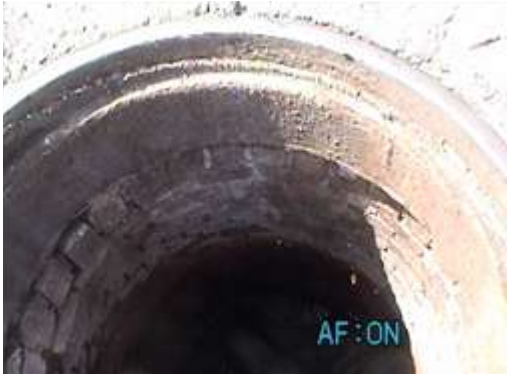
Defect 2

☒ **Leaks**

Frame leaks

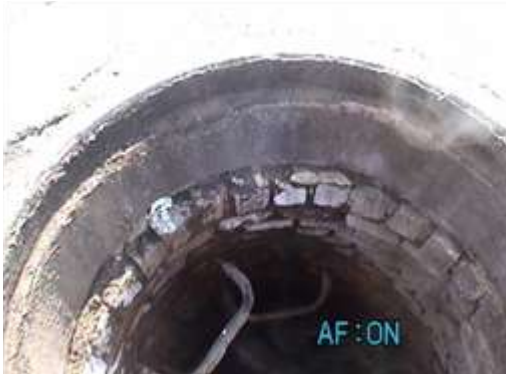
Defect 3

Infiltration: ☐ None ☐ Joint ☐ Cracks ☒ **Mortar** ☐ Roots ☐ Wall

Infiltration: ☐ None ☐ Joint ☐ Cracks ☐ Mortar ☐ Roots ☒ **Wall**

Infiltration

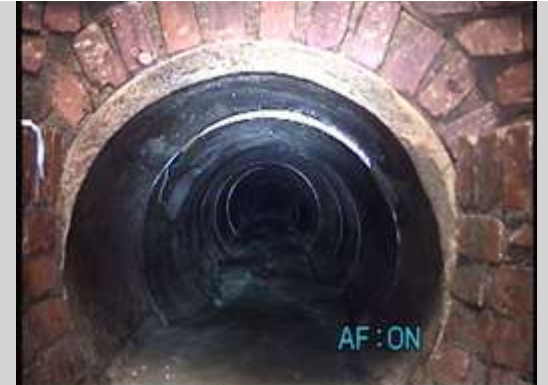
12 O'Clock Outflow

Pipe Height: **21.6** (in.) Rod and Bar (Angled)
Pipe Material: **Clay** ☐ Pipe Lined
Invert Depth: **11.90** (ft.) Flow Characteristics: **Fast**
Deposits: ☒ None ☐ Mud ☐ Sludge ☐ Debris ☐ Grease
Silt Depth: (in.) Deposits Extent:
Infiltration: **None** Pipe Seal Cond: **Sound**

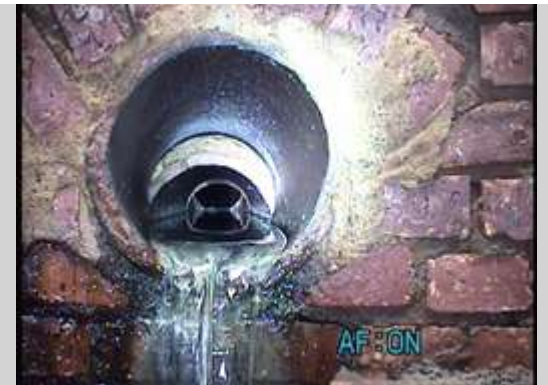
3 O'Clock Inflow

Pipe Height: **8.4** (in.) Rod and Bar (Angled)
Pipe Material: **Clay** ☐ Pipe Lined
Invert Depth: **10.00** (ft.) Flow Characteristics: **Fast**
Deposits: ☒ None ☐ Mud ☐ Sludge ☐ Debris ☐ Grease
Silt Depth: (in.) Deposits Extent:
Infiltration: **None** Pipe Seal Cond: **Sound**

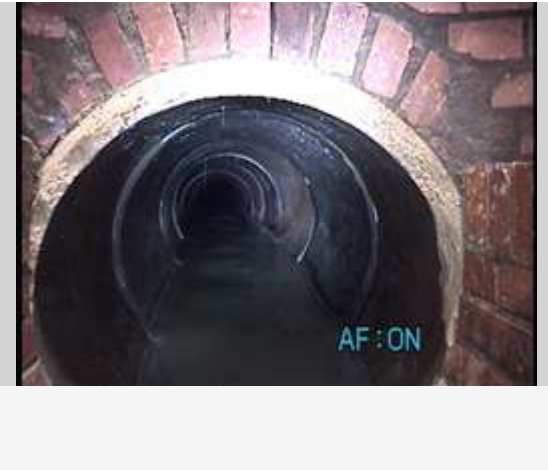
6 O'Clock Inflow

Infiltration: **None** Pipe Seal Cond: **Sound**
